Navajo Abandoned Uranium Mine

Site Screen Report

**Mine Name: Whirlwind
Mine ID: 196**

April 2012

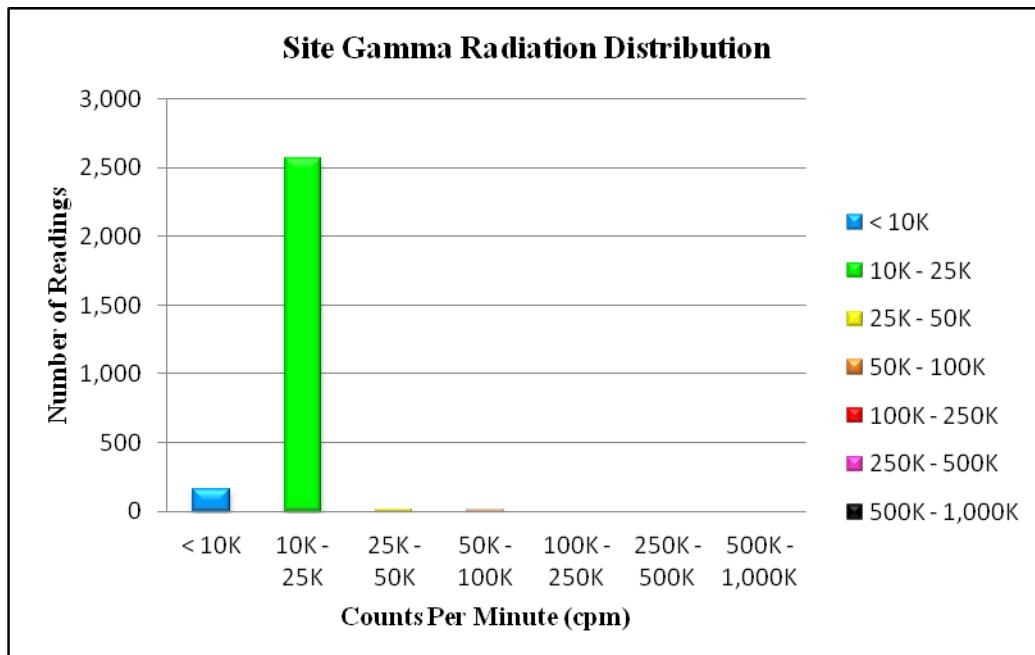
Highest gamma radiation measurement: 66,380 counts per minute (cpm)

Background Average: 10,705 cpm **Two Times Background:** 21,410 cpm

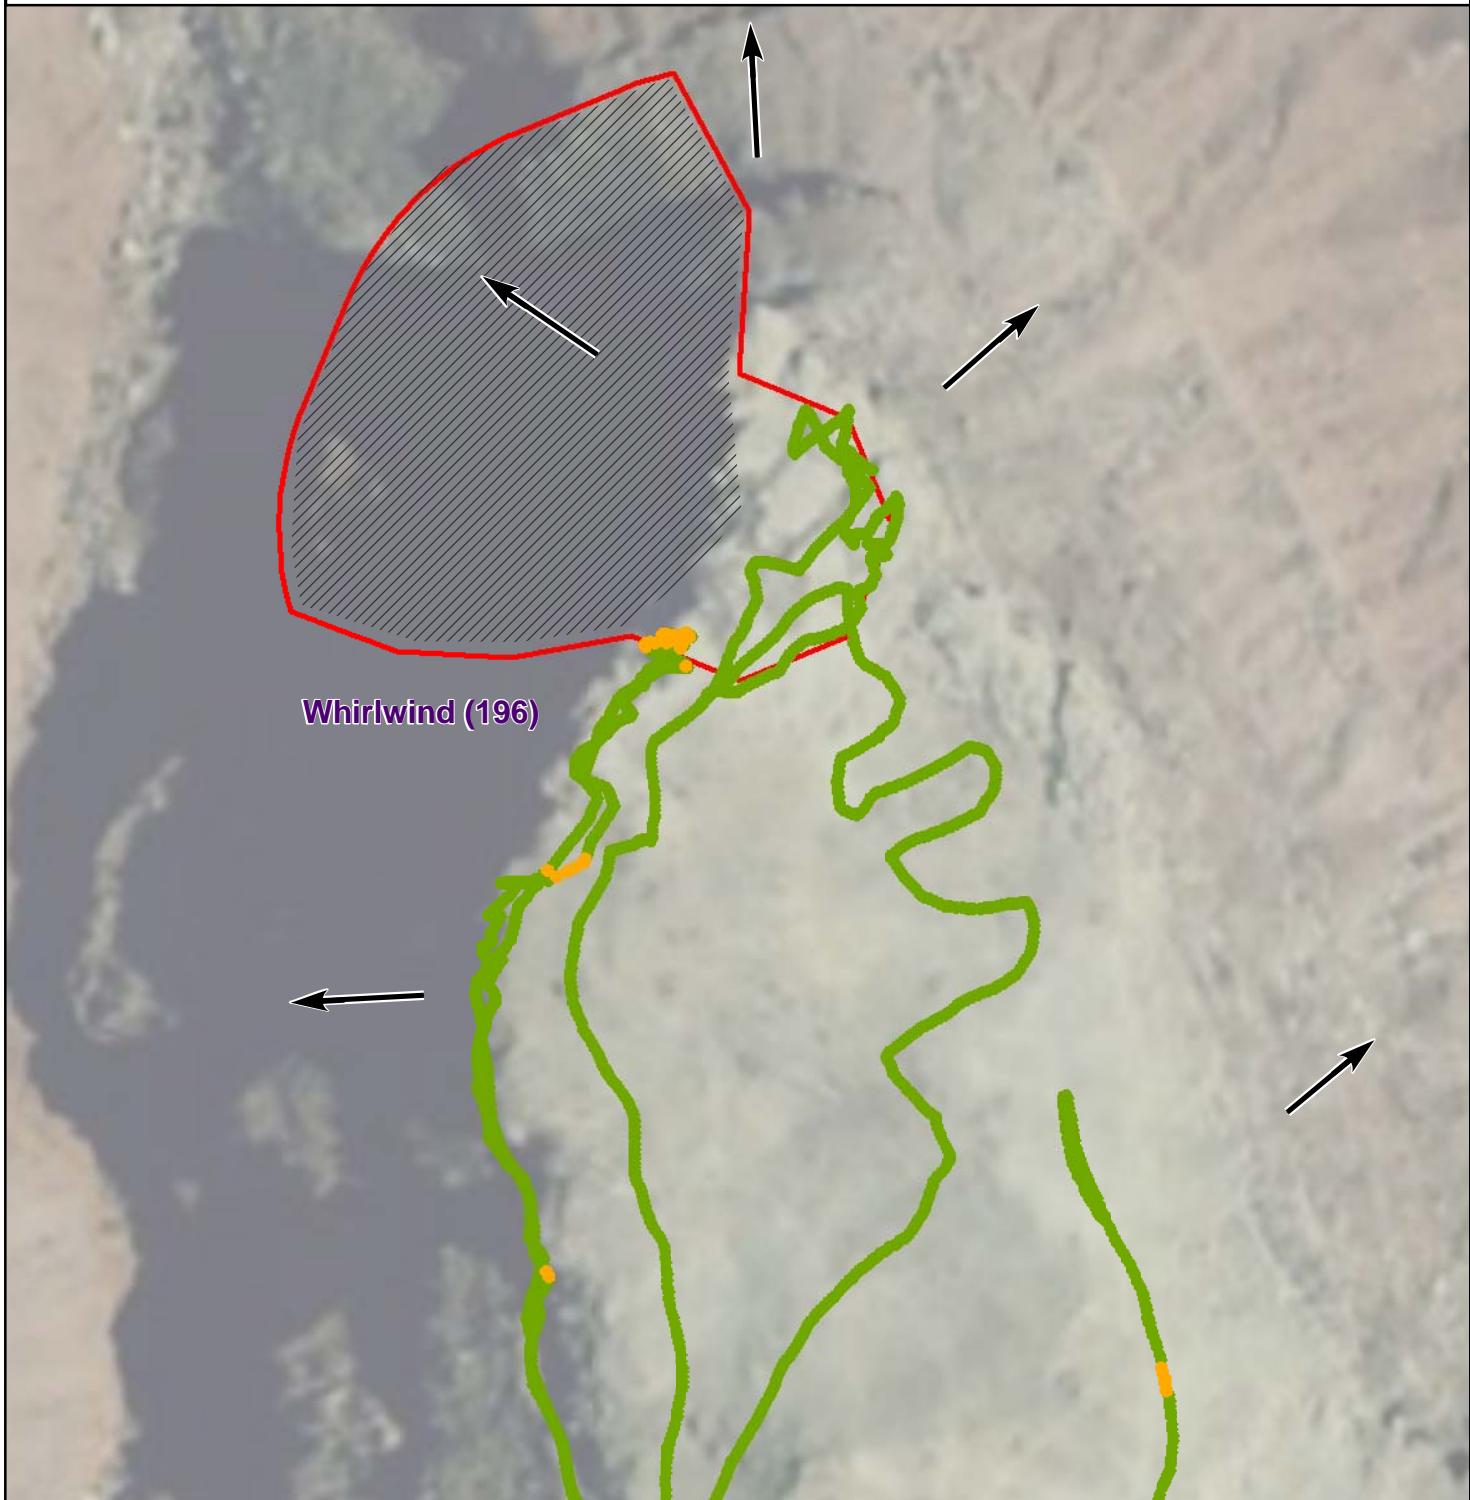
Figure 1 - Gamma Radiation Measurements, Above Two Times Background
Whirlwind (196)
Oljato Chapter, Navajo Nation

A total of 2,756 gamma radiation measurements were collected from the mine site, ranging from 8,420 cpm to 66,380 cpm. The measurements are represented in Figures 1 and 2.
